New York State Department of Transportation

Yellow Flag NB2222W014

BIN: 1065318

Location: Span 153 – S1 at Pier 153 over 3rd Avenue Westbound

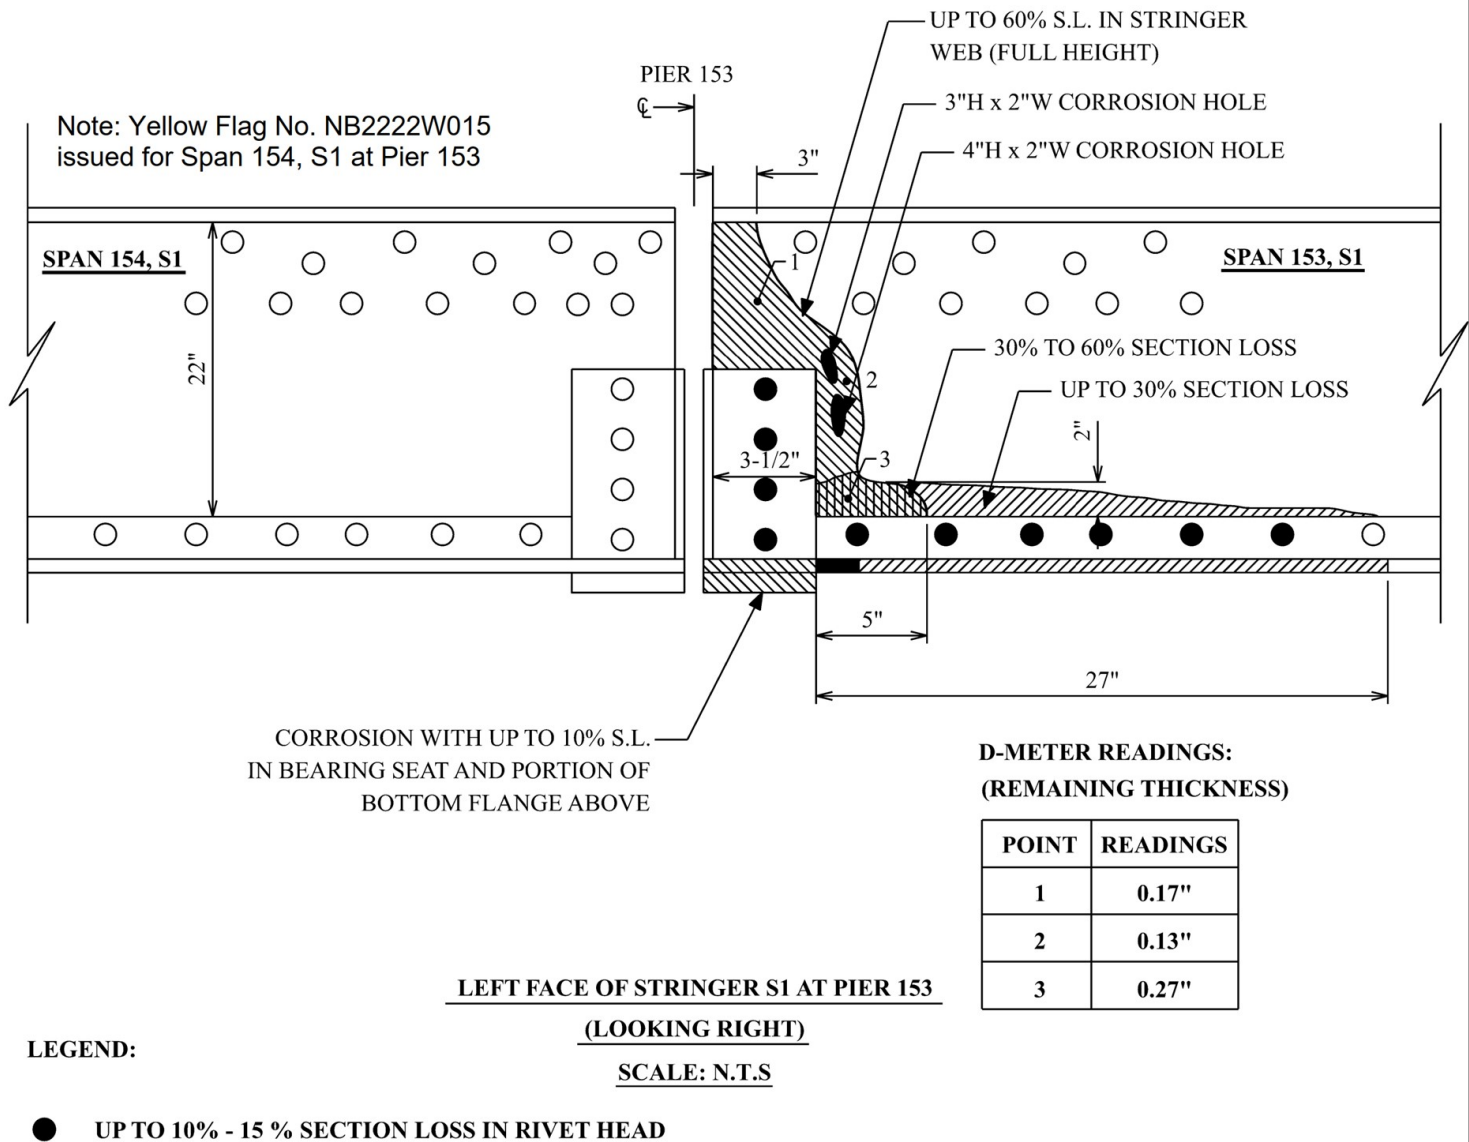
Photo Number: 2

Description: Stringer S1 end at Pier 153 exhibits severe corrosion with up to 60% section loss (20" high) in the web adjacent to the connection angle (D-meter reading for remaining thickness is 0.17" and 0.13"). There are two holes (3"H x 2"W and 4"H x 2"W) in the stringer web adjacent to the connection angle. The remaining web thickness between the two holes was observed as 0.13" from D-meter reading.

**Attachment Description: FLAG DETAIL SKETCH 1**

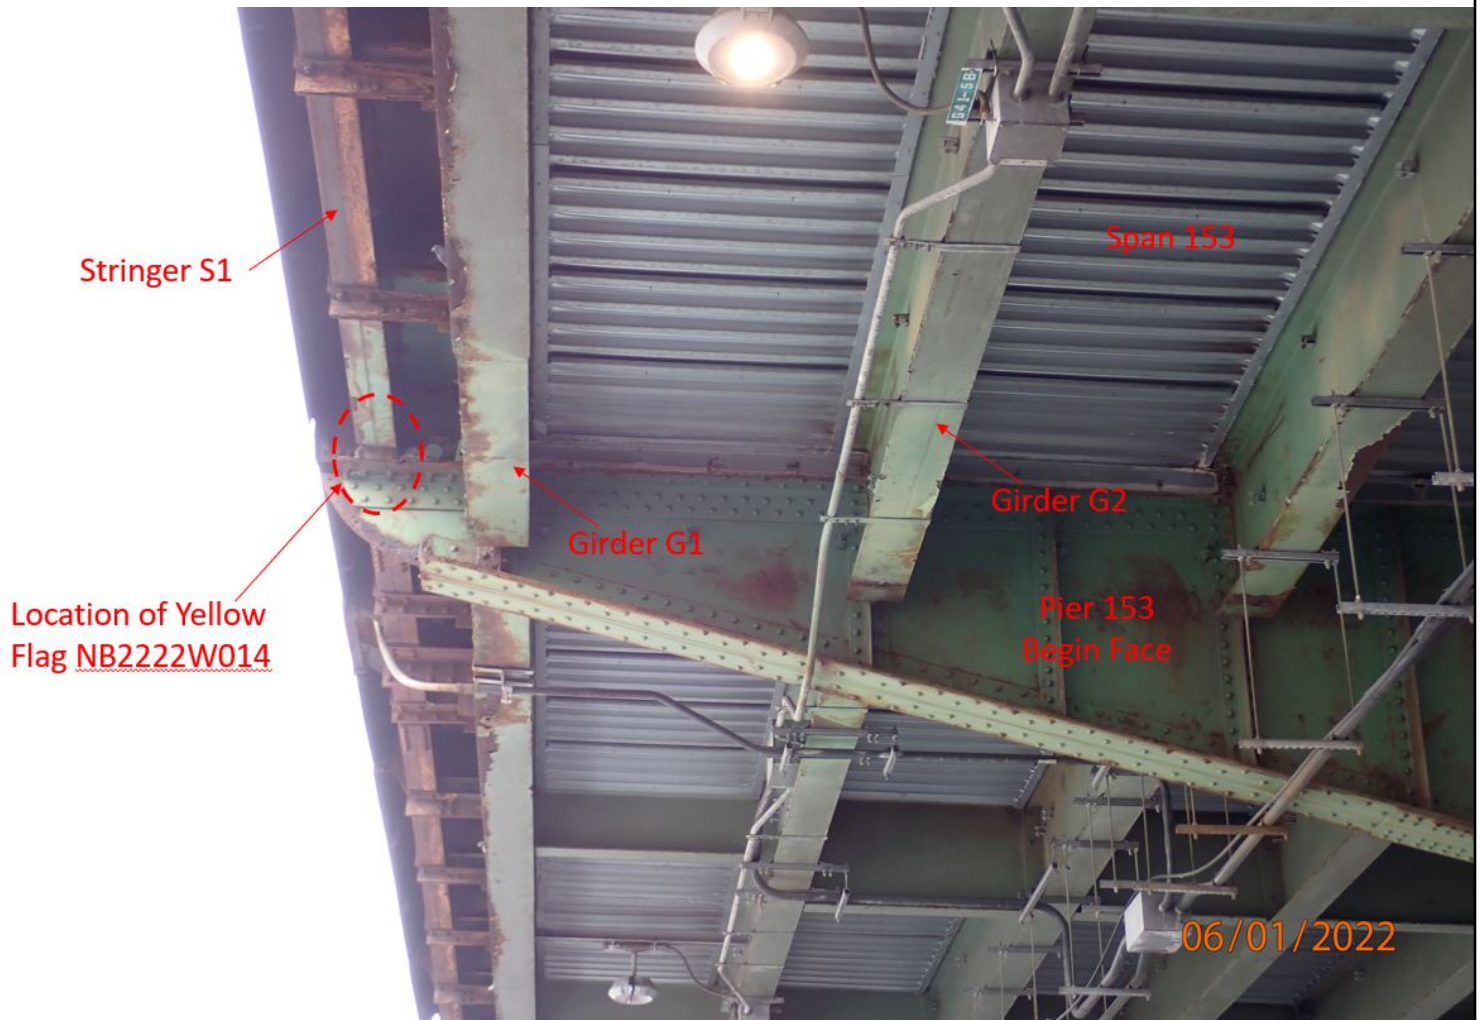
Photo Number: 4

Attachment Description: Photo 1: General view of flag location in Span 153 at Pier 153. Looking end.

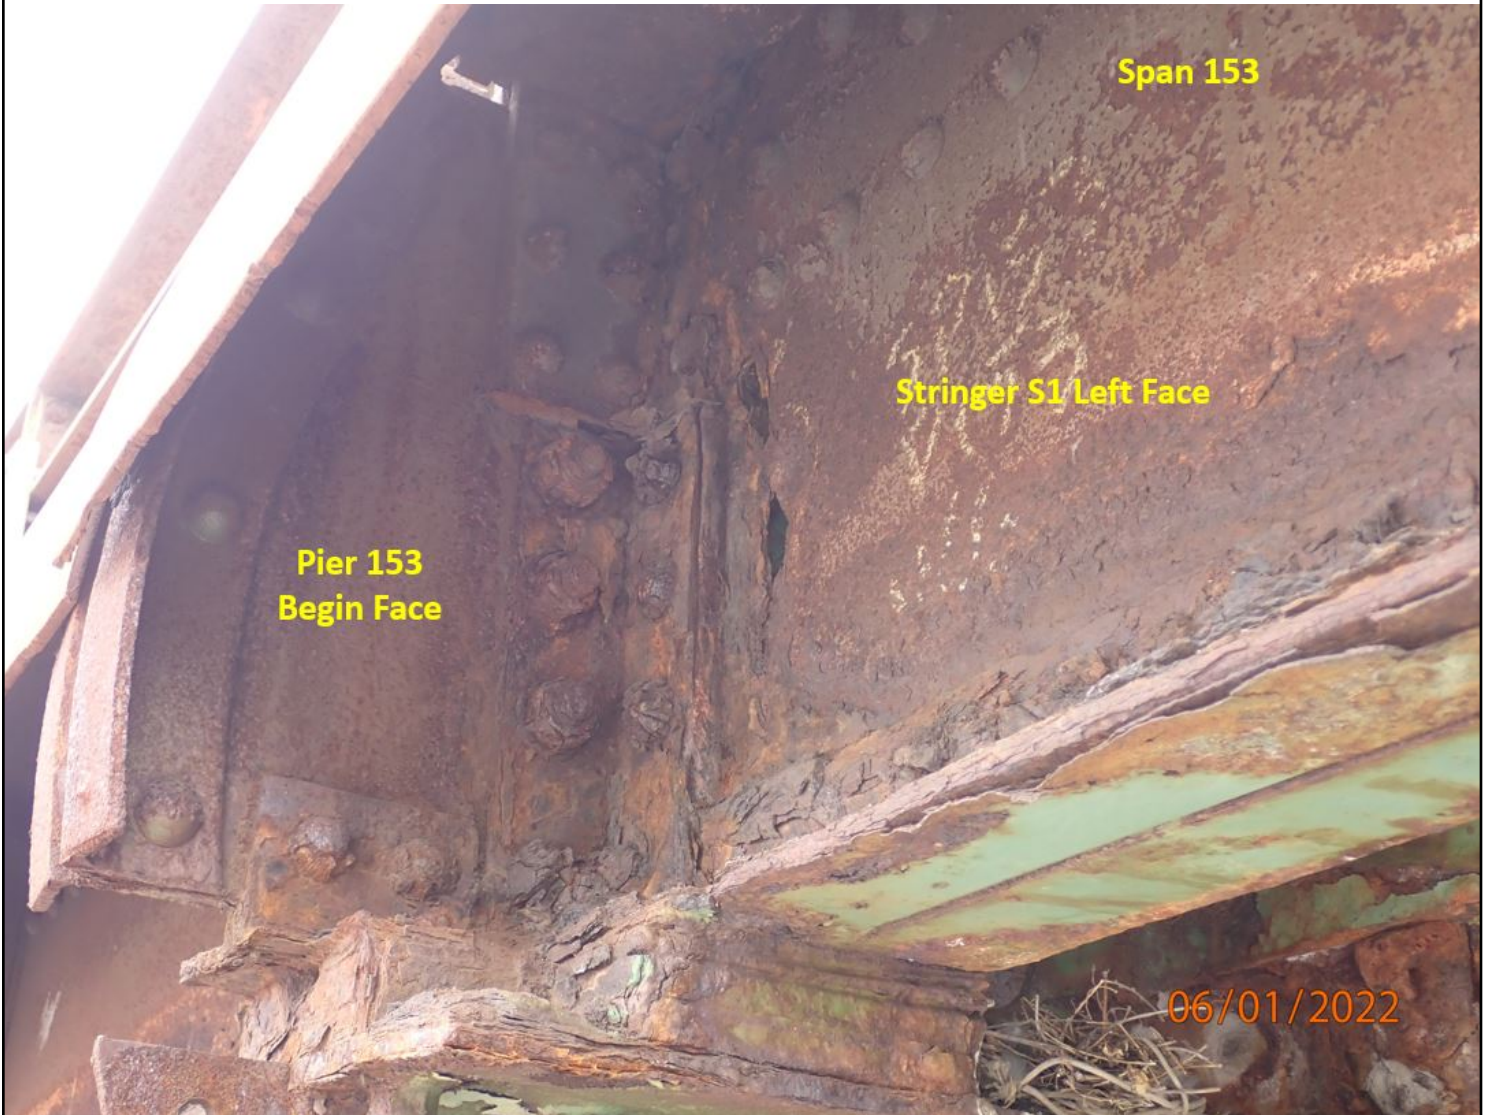
Photo Number: 5

Attachment Description: Photo 2: Span 153, Stringer S1 at Pier 153 - General view of left side of stringer web. Looking end - right.

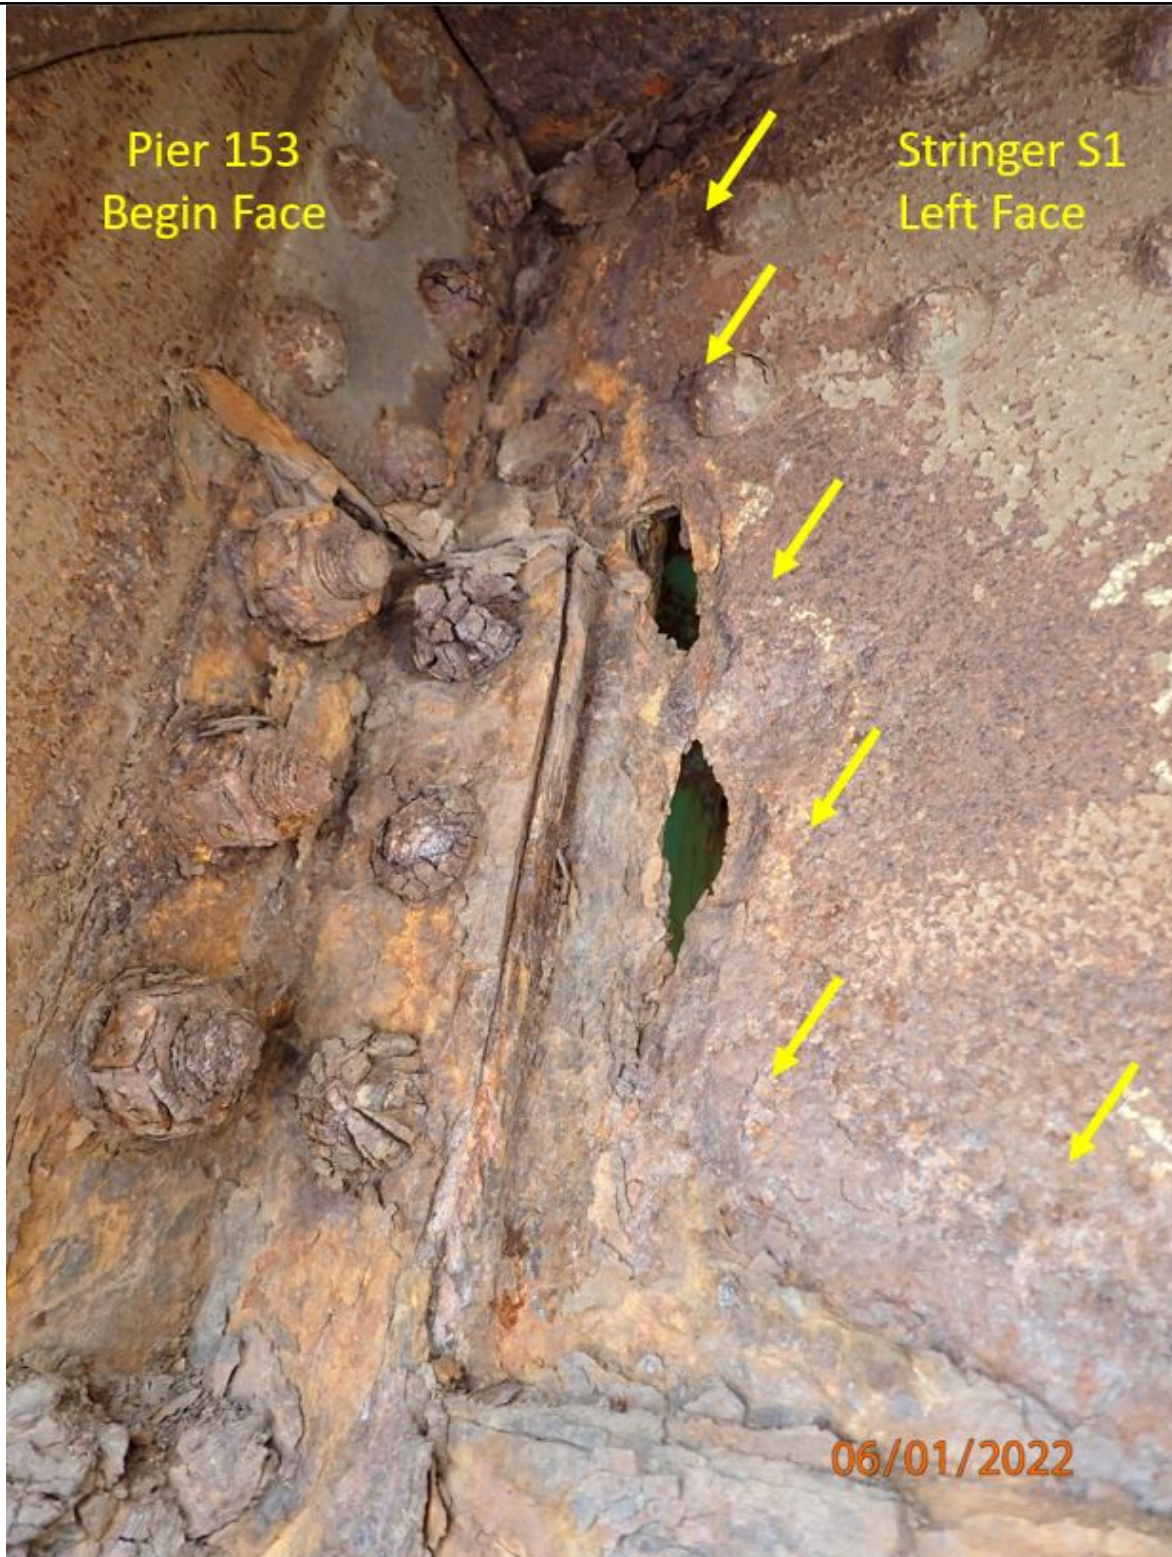
Photo Number: 6

Attachment Description: Photo 3: Span 153, Stringer S1 at Pier 153 - Corrosion holes and section loss in the stringer web left face. Looking right.

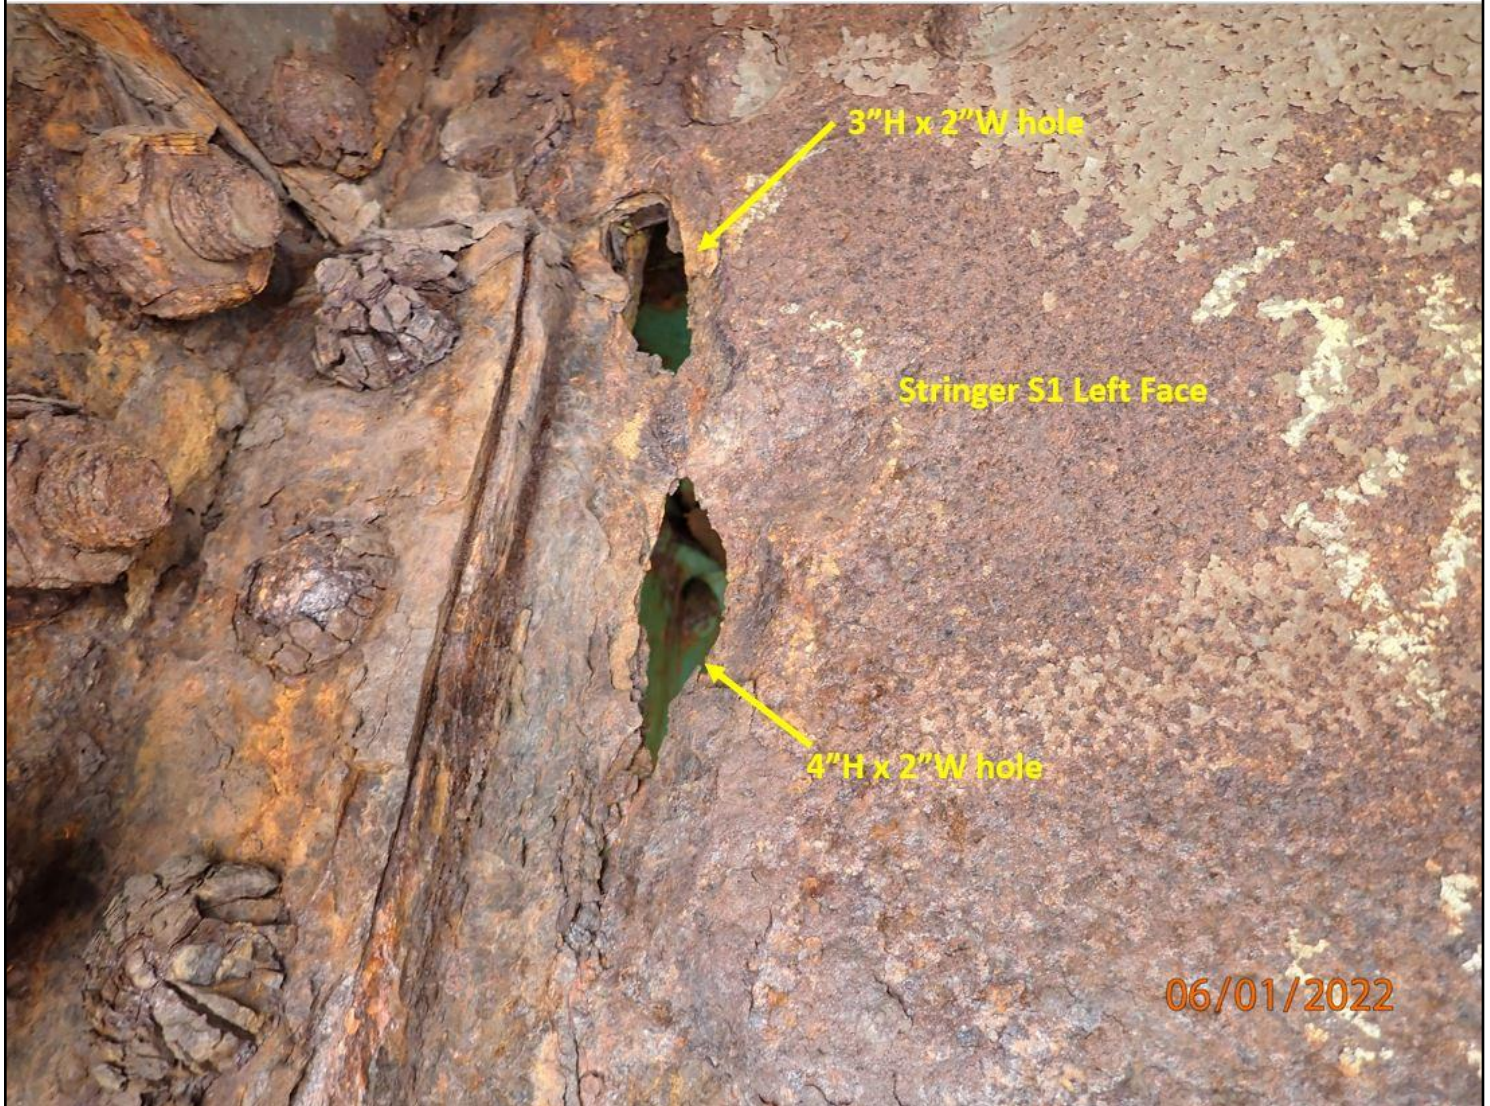
Photo Number: 7

Attachment Description: Photo 4: Span 153, Stringer S1 at Pier 153 - Close up view of the corrosion holes in the stringer web adjacent to the connection angle, measuring 3\"H x 2\"W and 4\"H x 2\"W. Looking right.

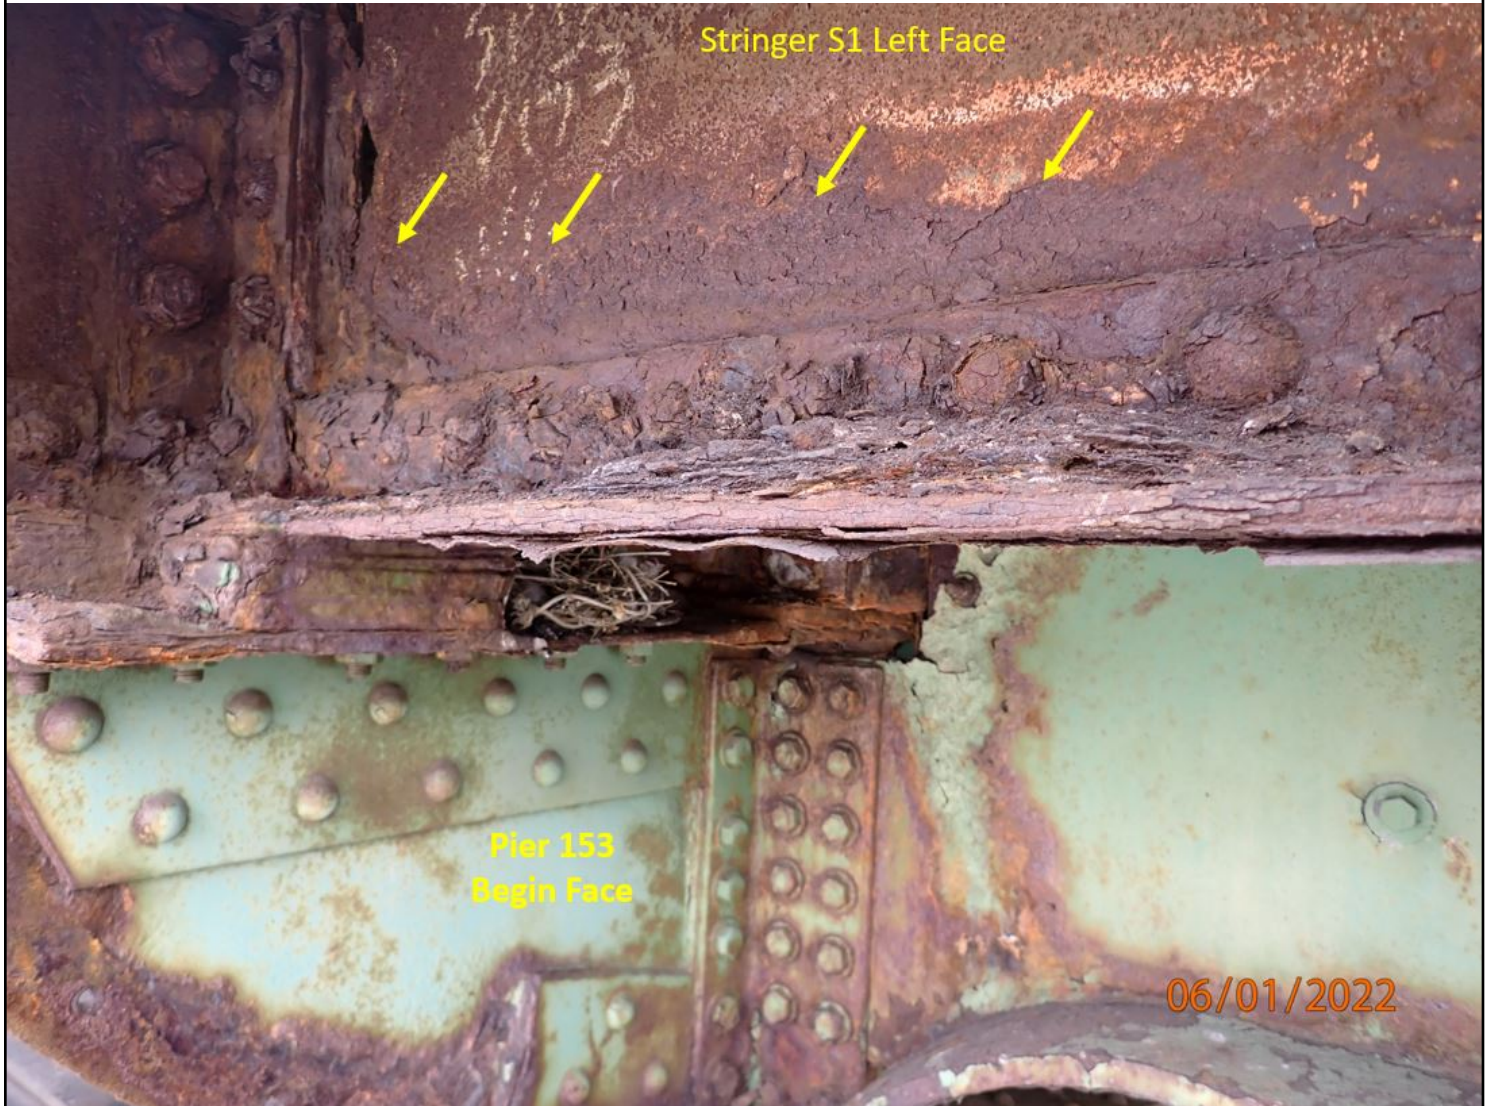
Photo Number: 8

The stringer web exhibits varying section loss along the left bottom flange angle for a total length of 27". The lower portion (2"H) of the web adjacent to connection angle, exhibits section loss varying from 30% to 60% (D-meter reading – 0.27" remaining thickness) for 5"L and then up to 40% section loss for the remaining length of 22". Four (4) rivets in the connection angle and six (6) rivets in the web angle exhibit 10% to 15% section loss in rivet heads.

The outstanding leg of the bottom flange angle on the left side has a 2"L x 3"W corrosion hole adjacent to the bearing seat. The remaining part of the outstanding bottom flange angle leg exhibits up to 40% section loss (32"L x full width). The stringer bearing seat at the begin face of Pier 153 exhibits corrosion with up to 10% section loss.

Attachment Description: Photo 5: Span 153, Stringer S1 at Pier 153 - Section loss in stringer web along the left bottom flange angle leg and up to 40% section loss in outstanding leg of left angle in bottom flange. Looking end-right.
